Ice Column Design Concept for Summit Station

Laboratory Testing Results

Amy M. Burzynski, Jason C. Weale, and Lynette Barna

June 2013

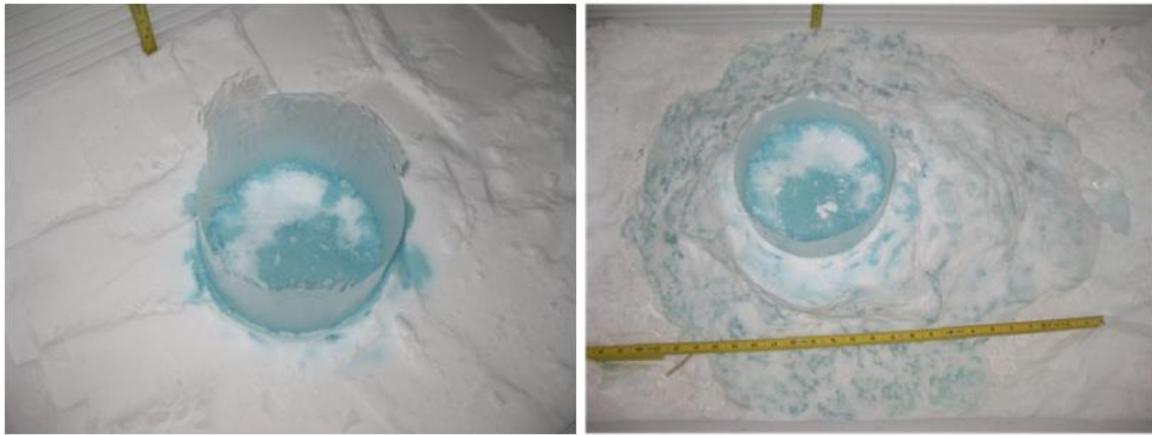
We set the footer into the compacted snow base, approximately 0.64 cm (0.25 in.) deep, then slowly poured about 1 L (0.26 gal.) of near-freezing water from the slurry, mixed with a couple drops of blue food coloring to improve visibility. The depth of 0.64 cm was arbitrary, but sufficient to provide enough distance between the bottom of the column and the bottom of the compacted snow base to illustrate the migration of pore water (in this case, the slurry) through the pore spaces in relatively densely compacted snow. The initial liter of water was intended to form a frozen seal at the base of the footer. After the first liter froze, we filled the footer with an additional 5 L (1.32 gal.) of blue water. We observed a few small leaks on the snow surface around the edge of the footer base, but they appeared to stop growing after about 10 minutes. We let the water freeze overnight. The next morning we heated the footer for about 45 seconds and then lifted it with the hand crank. This revealed only a thin shell of the outer base of the footer; most of the water leaked out the bottom into the compacted snow (Fig. 4).

Figure 4. Attempt to form an ice column on a compacted snow base: most of the liquid leaked out the bottom (right), leaving only a thin shell above the surface (left).

The first challenge we encountered was losing water through pore spaces and melting of the snow beneath the base of the footer, despite compacting the snow to a density of approximately 0.51. We solved this issue in the laboratory test by using an ice base in place of compacted snow. An impermeable base layer would be necessary in the field. Further studies should investigate methods, materials, and depths required to provide an impermeable base layer for initial column placement as this concept moves forward.

- An impermeable base material is necessary to prevent losing water or slurry out the bottom of the footer.
- The top plate and access tube of the footer should be heated. Heat in these areas would also benefit the lift process.

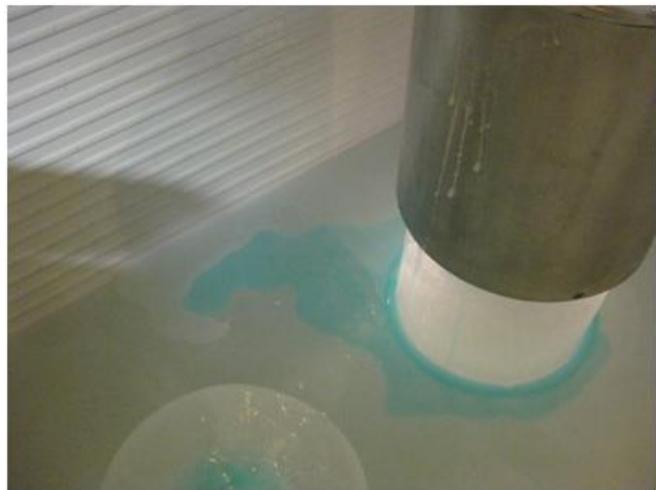
Figure 6. Water leaked out while forming a frozen seal prior filling the footer. We formed a watertight seal by pouring low volumes of near-freezing water in three consecutive rounds.

Third, leaking is of concern when filling the footer. It took three attempts of adding 0.25 L (0.07 gal.) of near-freezing water to create a complete seal between the slip form footer and the existing ice column segment.
